AFCEC-CO-TY-TR-2018-0001

## **CONVERTING HANGAR HIGH EXPANSION FOAM SYSTEMS TO PREVENT COCKPIT DAMAGE: FULL-SCALE VALIDATION TESTS**

Gerard G. Back and Daniel Martin

**AIR FORCE CIVIL ENGINEER CENTER  
OPERATIONS DIRECTORATE**

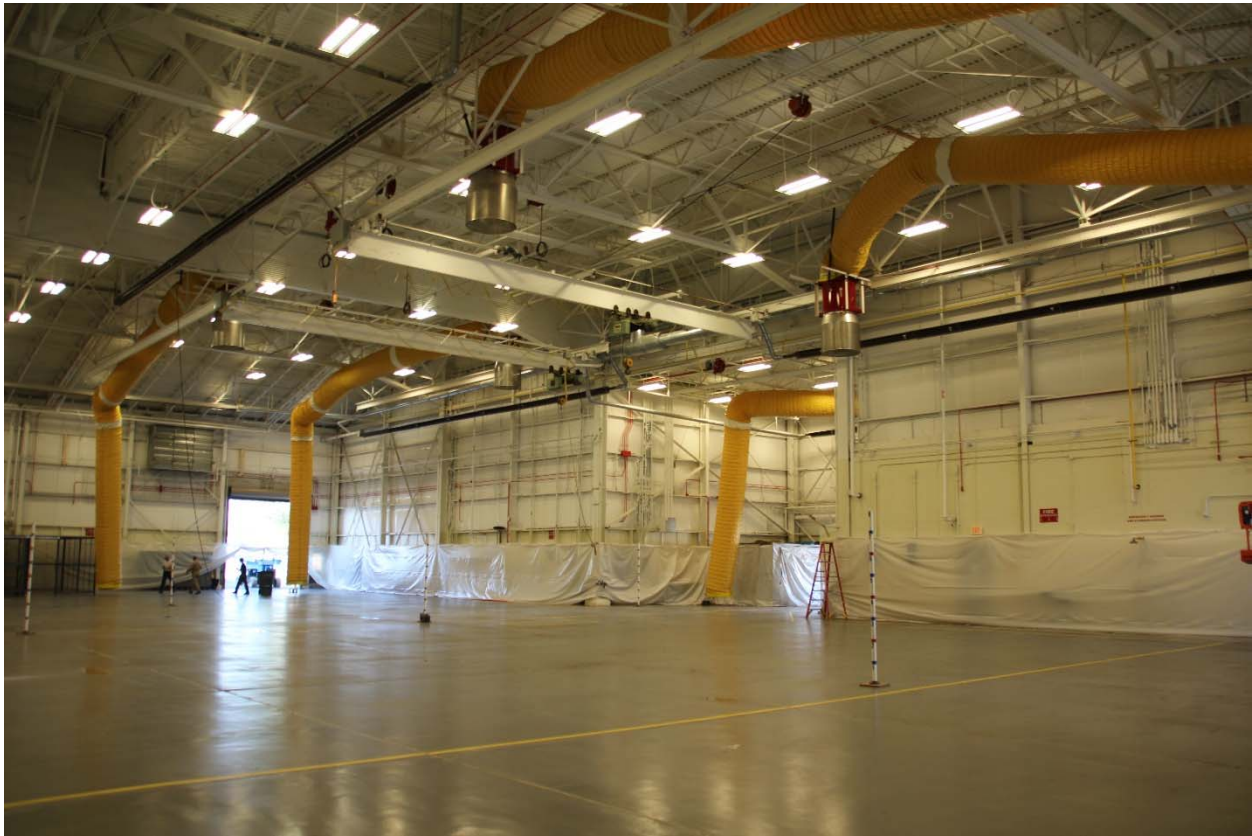
**Figure 3. Protective Curtain on Hangar Boundaries**

To minimize the exposure of the hangar boundaries (i.e., painted surfaces and the devices installed on the walls including electrical components), a poly curtain was installed around the inside perimeter of the hangar. The curtain was hung from 5/16 in. nylon rope run through a series of eyebolts installed on each boundary about 8 ft. above the floor. The curtain was made from 6 mil poly rolls, 10 ft. by 100 ft. long. The curtain was attached to the rope using nylon wire ties. A photograph showing the curtain is provided as Figure 3.

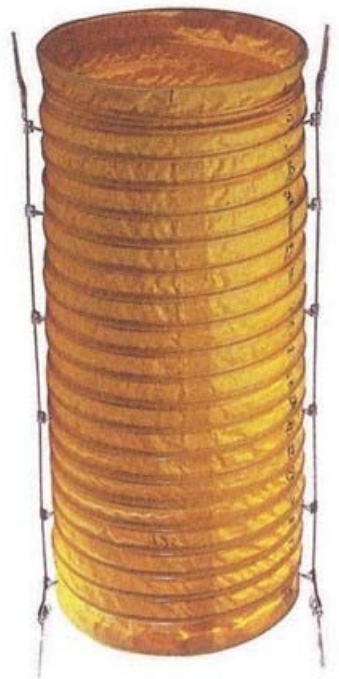
**Figure 9. Vertical Duct Configuration**

The vertical runs are equipped with a cable support system that runs down opposite sides of the duct as shown in Figure 9. The vertical runs were suspended from the overhead using  $\frac{1}{2}$ " steel cable connected to the ceiling trusses. The inlets to the vertical ducts were approximately 16 in. above the floor. A typical ductwork run is shown in Figure 10.

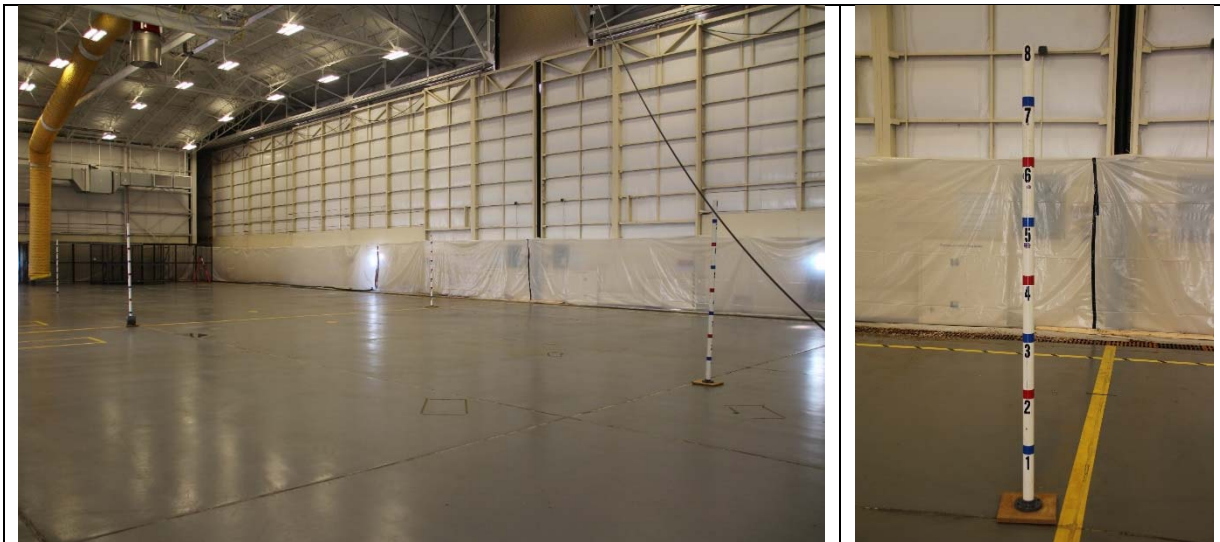
**Figure 12. Depth Indicator Locations**

To aid in assessing the foam depth as a function of time, five, depth indicators were installed in the hangar during each test. The depth indicators consisted of a 2 in. PVC vertical pipe stand with markings at one foot increments. Three depth indicators were installed equally spaced down the centerline of the hangar (i.e., the location of the fuselage when a plane is parked in the hangar), and the remaining two positioned at the wing tip locations. A close up of a depth indicator and their installed locations are shown in Figure 12.

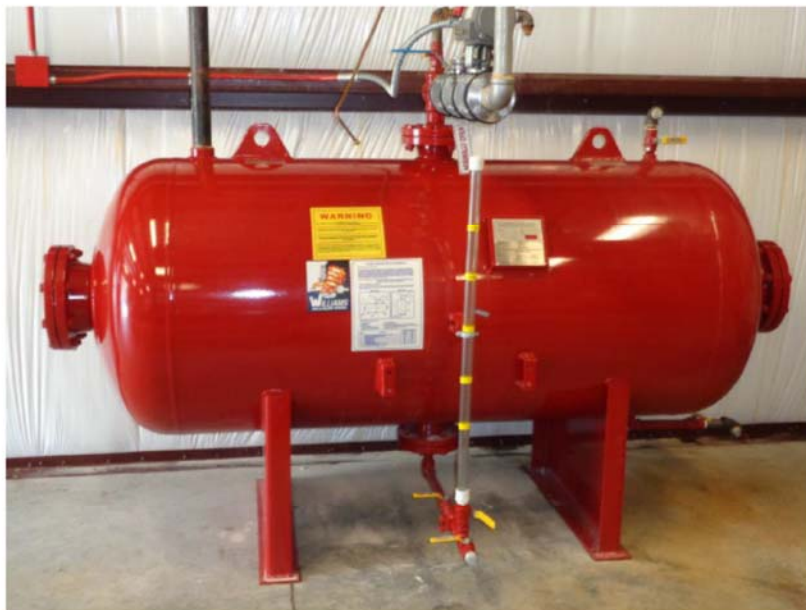
### **FOAM CONCENTRATE AND HARDWARE.**

<b>Foam concentrate type:</b>	Chemguard C-2, 2% High Expansion Foam Concentrate
<b>Foam concentrate percentage:</b>	2%
<b>Lot number – (for replacement):</b>	C2701 (Manufactured 03/17) & C2603 (Manufactured 08/16)
<b>Foam concentrate tank type:</b>	300-gallon capacity Horizontal bladder tank (1)
<b>Serial Number of tank(s):</b>	10 – 8677
<b>Material of Construction:</b>	Carbon steel with Flexiliner bladder
<b>Leakage from tank:</b>	No
<b>Comments:</b>	N/A

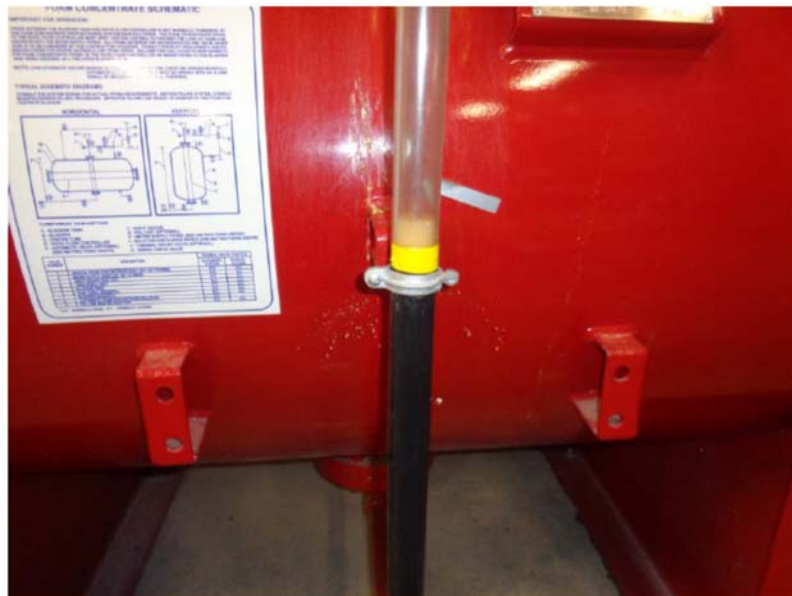
Initial foam concentrate level

Upon following OEM procedures for a foam concentrate level check, the bladder tank was isolated from the riser, the tank shell drain valve opened to drain water from the tank shell; the tank shell vent valve was opened, the bladder vent valve was opened and once all the water had drained from the tank shell, the bladder tank was found to be only half full.

The “black” foam concentrate initially found in the sight glass appeared to be as a result of contact with the carbon steel pipe attached to the sight glass tube.

Base Maintenance Department provided a supply of foam concentrate and the bladder tank was topped-off to the appropriate level.

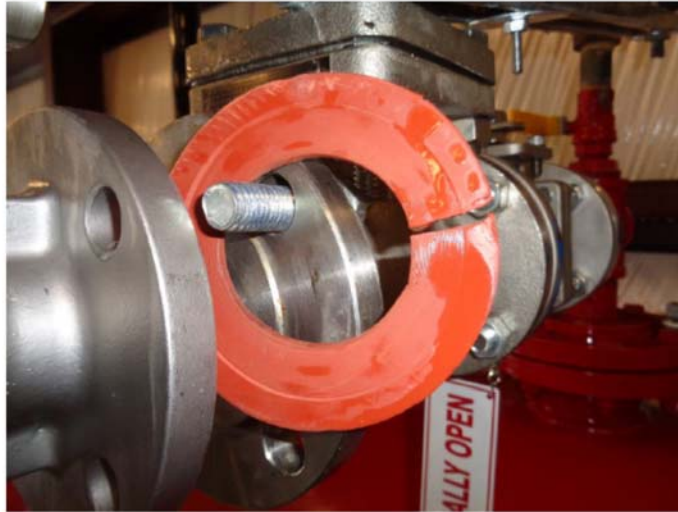
During the re-pressurisation of the bladder tank, one (1) of the gaskets in the foam concentrate line to the ratio controller failed. Subsequently, all four (4) gaskets in the foam concentrate line were replaced by the base Maintenance Department.
